**Flood Control Project Maintenance
Levee Inspections**
LMA District Cover Sheet
Spring 2018 Levee Inspection Results

Sutter Maintenance Yard Maintenance Area 0016

Spring 2018 Levee Inspection Results

Waterway			Bank	Unit Miles
Unit No. 01 Feather River			Right	4.06
	Spring (March - May)	Summer (June - August)	(September - November) Fall	Winter (December - February)
Unit Maintenance Rating (Fall Only)				
Date of Inspection	3/20/2018 - 3/20/2018			
DWR Inspector	Sterling York			
Accompanied By	Shawn Freitag Sutter Maintenance Yard

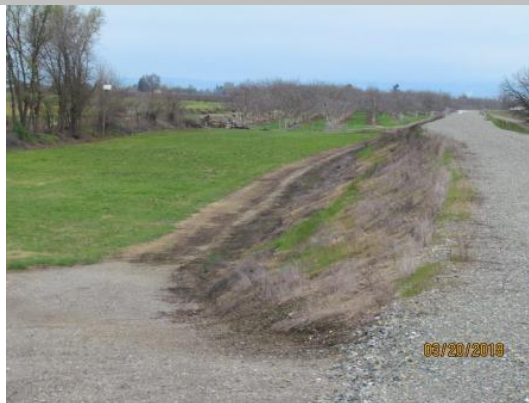
Photo 1 of 1 : SP_2018_MA0016_302_8_20180402_00013.jpg

LM Start	0.01	Rating **	A	Issue No.	8
LM End	4.05	Issue Type +	Ma	Location *	LS
Category	Earthen Levee			GPS Latitude/Longitude	
				Start	End
Item	Vegetation			39.310826 °	39.310826 °
				-121.636395 °	-121.637674 °
DWR ID	DWR_MA0016_01_s_2018_8				
Comment Code					
V1 : Control annual grass and weeds on the levee slopes and easements.					
Inspector Comment					
The annual vegetation is well maintained, Spring 2017.

View looking upstream landside of the well maintained annual vegetation, Spring 2018.

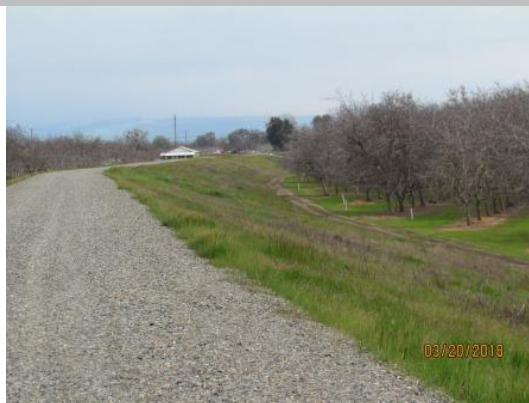
Photo 1 of 1 : SP_2018_MA0016_302_7_20180402_00014.jpg

LM Start	0.01	Rating **	A	Issue No.	7
LM End	4.05	Issue Type +	Ma	Location *	WS
Category	Earthen Levee			GPS Latitude/Longitude	
				Start	End
Item	Vegetation			39.255964 °	39.310826 °
				-121.636421 °	-121.637674 °
DWR ID	DWR_MA0016_01_s_2018_7				
Comment Code					
V1 : Control annual grass and weeds on the levee slopes and easements.					
Inspector Comment					
The annual vegetation is well maintained, Spring 2017.

View looking upstream waterside of the well maintained annual vegetation, Spring 2018.

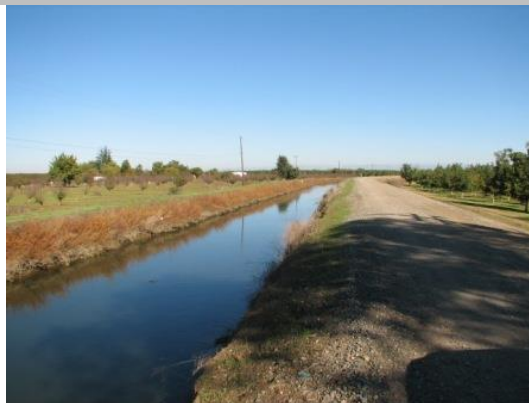
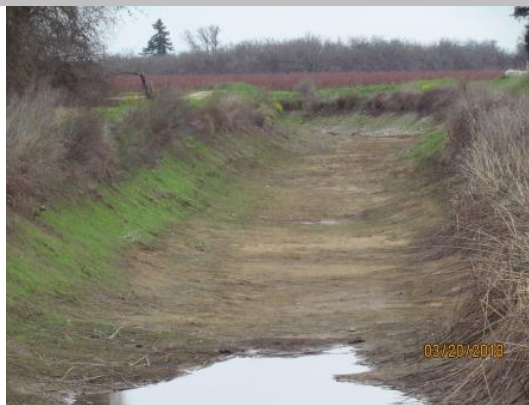
Photo 1 of 2 : SP_2018_MA0016_302_14_20180302_00006.jpg

LM Start	2.85	Rating **	M	Issue No.	14
LM End	3.08	Issue Type +	En	Location *	LS
Category	Earthen Levee			GPS Latitude/Longitude	
				Start	End
Item	Encroachments			39.293675 °	39.296748 °
				-121.636615 °	-121.638192 °
DWR ID	DWR_MA0016_01_s_2012_14				
Comment Code					
DT : Ditch					
Inspector Comment

Agricultural ditch land side slope and toe.

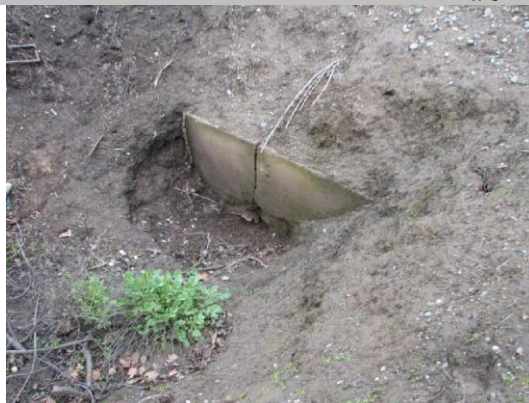
Photo 1 of 2 : UCIP_SP_2018_51931_65782.jpg

FS_ID:51931
DS_ID:17125
EP_NO: N/A
Repair Type: Non-Urgent
Crossing Status: Found
UCIP Comments: 5/22/2017 LS inlet buried. WS access being blocked off by over grown vegetation. Pipe has been selected for internal cleaning and inspection as part of the DMP project. (DWR Sutter Yard - A/Freitag)12/1/2016 LS inlet completely buried. (DWR Sutter Yard - A/Freitag)5/26/2016 LS inlet was completely buried.6/8/2015 Concrete headwall is still cracked and inlet is buried. It was said to be replaced with the SBFCA project but the project skipped over in this area.12/29/2014 Same as last inspection.5/19/2014 Same as last inspection.11/6/2013 Same as last inspection.5/14/2013 SBFCA project recommends replacing in accordance with title 23. Same as last inspection.12/11/2012 Concrete headwall on LS toe is cracked through middle and pipe is buried in soil. pipe appears corroded.
FIELD_STRUCT_DESC: 1 of 2: 24-inch corrugated metal drainage pipe through the levee, 16.6 feet below the crown. Concrete headwalls on both the waterside (WS) and the landside (LS) ends. Flap gate on the WS end. [Additional Reference(s): DWR Levee Log, 2005. USACE Sacramento O&M Manual 148, August 1955, (Station 646+96)].

Headwall at LS toe is cracked and the inlet is buried in soil.

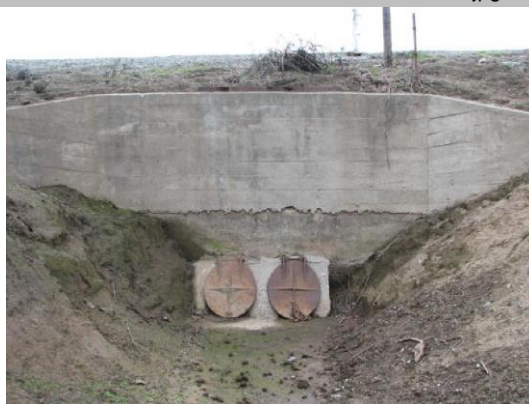
Photo 2 of 2 : UCIP_SP_2018_51931_65781.jpg

Headwall on WS toe with flap gates.

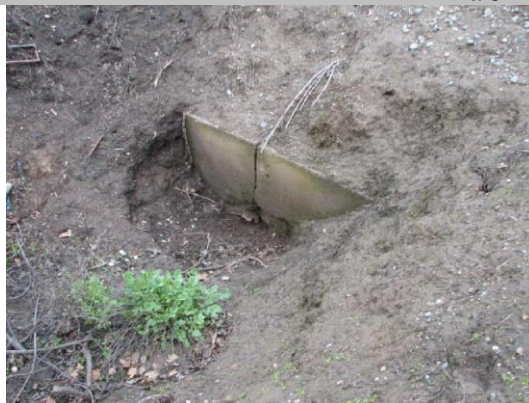
Photo 1 of 2 : UCIP_SP_2018_51932_65780.jpg

FS_ID:51932
DS_ID:17183
EP_NO: N/A
Repair Type: Non-Urgent
Crossing Status: Indicator Found
UCIP Comments: 5/22/2017 LS inlet is buried. WS access is being blocked off by overgrown vegetation. (DWR Sutter Yard - A/Freitag)12/1/2016 LS inlet is completely buried. (DWR Sutter Yard - A/Freitag)5/26/2016 LS inlet was completely buried.6/8/2015 Concrete headwall is still cracked and inlet is buried. It was said to be replaced with the SBFCA project but the project skipped over in this area.12/29/2014 Same as last inspection.5/19/2014 Same as last inspection.11/6/2013 Same as last inspection.5/14/2013 SBFCA project recommends replacing in accordance with title 23. Same as last inspection.12/11/2012 Pipe buried on LS toe and should be inspected along with adjacent 24-inch once uncovered.
FIELD_STRUCT_DESC: 2 of 2: 24-inch corrugated metal drainage pipe through the levee, 16.6 feet below the crown. Headwalls at both the waterside (WS) and landside (LS) ends and a flap gate on the WS toe. [Additional Reference(s): DWR Levee Log, 2005. USACE Sacramento O&M Manual 148, August 1955 (Station 646+96)].

Pipe should be located on either side of the one visible in this picture.

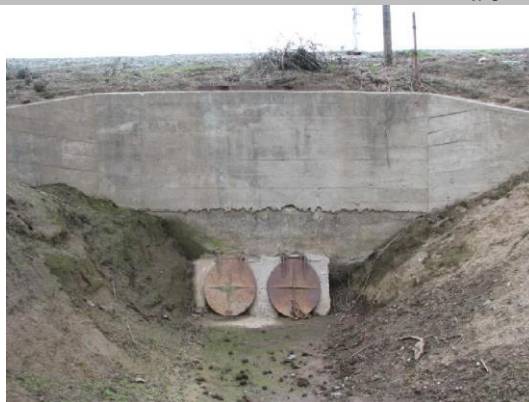
Photo 2 of 2 : UCIP_SP_2018_51932_65779.jpg

Headwall and flap gate on WS toe.

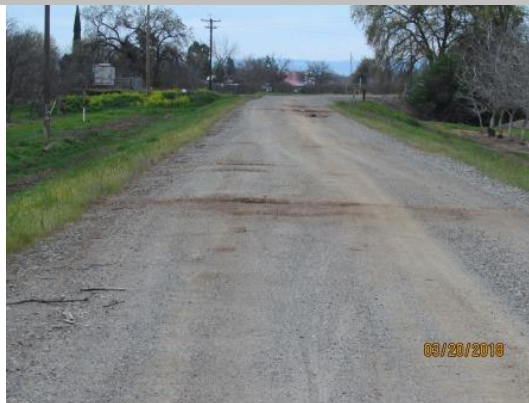
Photo 1 of 1 : SP_2018_MA0016_302_11_20180402_00017.jpg

LM Start	3.94	Rating **	M	Issue No.	11
LM End	4.09	Issue Type +	Ma	Location *	CR
Category	Earthen Levee			GPS Latitude/Longitude	
				Start	End
Item	Crown Surface / Depressions / Rutting			39.309154 °	39.311298 °
				-121.637694 °	-121.637554 °
DWR ID	DWR_MA0016_01_s_2018_11				
Comment Code					
C1 : Add appropriate material and re-grade the levee to bring the crown above the design elevation.					
Inspector Comment					
Re-grading and aggregate base is scheduled for summer 2018.

View looking upstream of the crown that needs aggregate base added for an all weather access road which is scheduled for summer 2018, Spring Inspection 2018.
